THE ORIGINAL ARCHITECTURE OF THE OSMAN HAMDİ BEY BOATHOUSE

Zeynep TANRIVERDİ**

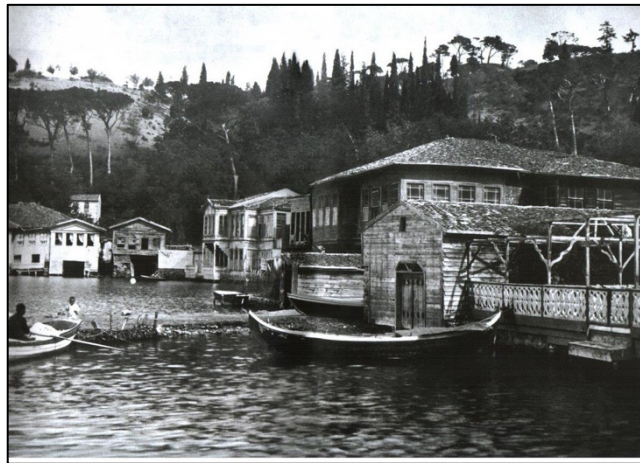
Figure 1. Photograph of various boathouses in Kandilli bay of Istanbul (National Geographic archive, 2013)

The maximum use of sea transportation and boathouses can be seen to have occurred historically until road and railway transportation were constructed in these areas. When sea transportation was still more popular than that of land, boathouses were built next to or as a part of main building structures to shelter and protect the boats of the owners of these coastal structures (Sökmen, 2013, 23). During the Ottoman period, especially in the 19th century boathouses were an indispensable part of all kinds of structures on the Golden Horn, Bosphorus and coastal shores, especially of seaside palaces, mansions and summer resorts in and around Istanbul (Sökmen, 2013, 17). These boathouses were open or closed structures, where boats could be pulled and tied after being used for sea transportation or moonlight pleasure trips (Figure 1) (Sökmen, 2013, 23).

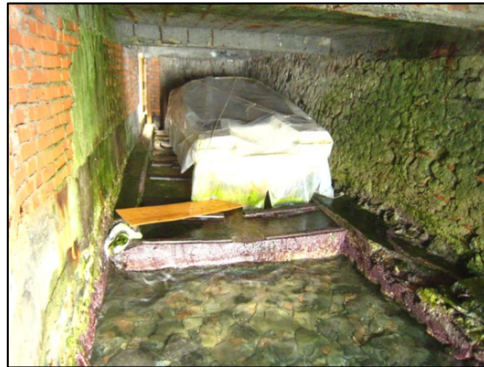
In the Ottoman period although they varied in size and may have been owned either by a foundation, a pier or the owner of a waterfront structure, boathouses were all similar in their working principles. The section associated with the sea side where the boat was towed, consisted of a lower part where two-winged doors with iron bars were located. From the basement door to the end of this space, boards were nailed, spaced around 34 cm. apart, in the shape of steps, called “felek”, which were coated with a mixture of wax and olive oil to allow the boat to slide easily while being pulled. As a boat was being pulled inside, wooden slides were transversely driven under it. Small boats were pulled in by three or four running boat rowers, while large boats were pulled in by ropes hooked unto one end of the boat while the other ends of the ropes were wound around revolving wheels located above. As the ropes wound around the wheels they pulled the boat into the boathouse. The tops of the boats pulled inside

were covered with protective thick cloths, while tools such as fishing baskets, fishing rods and harpoons were hung and stored in special sections (Figure 2) (Abdulaziz Bey, 2000; Sökmen, 2013, 24).

Figure 2. The waterpool and stepped ‘felek’ inside a boathouse (Sökmen, 2013, 24)

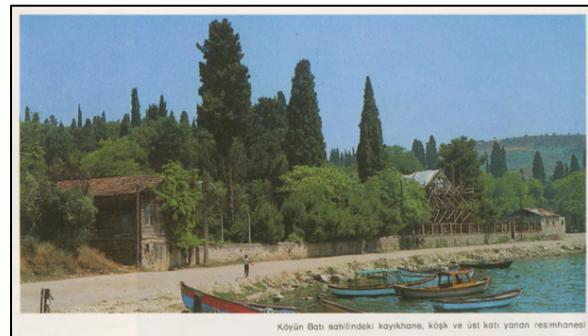
Figure 4. Osman Bey's Eskihişar Summer Home-sketch by unkown illustrator in 1916 and old photograph (Çentınor, 1993, 39; 1986, 9)

Osman Hamdi Bey¹, whose father owned a mansion in Gebze, had been familiar with this area since childhood. In 1884 he designed and built a summer vineyard home for himself consisting of a mansion, painting studio and boathouse on the west coast of the Gebze-Eskihişar village (Figure 4). For 26 years of his life (until 1910) he spent his summer months here, where he painted some of his most beautiful works (Çentınor, 1986, 12-13). Osman Hamdi Bey's

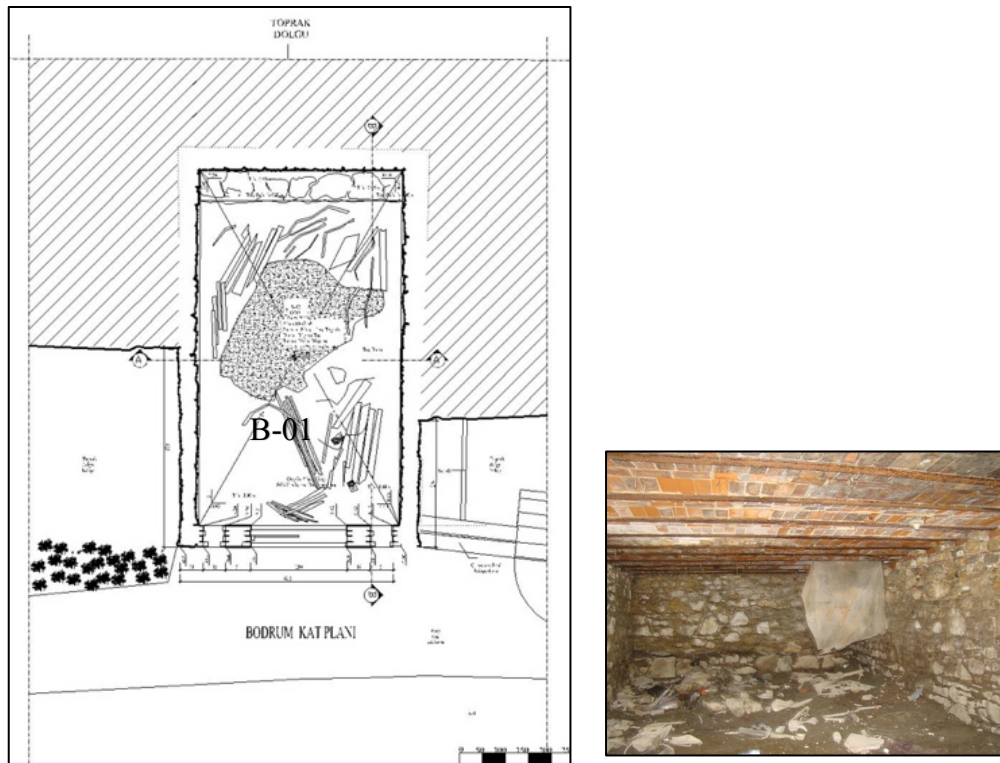
The boathouse structure had a rectangular plan and consists of a basement and a ground floor. The basement floor had a single space (B-01), slightly higher than sea level (Figure 5).

Figure 5. Basement Floor Plan and photo B-01 Room (Tanriverdi, 2011)

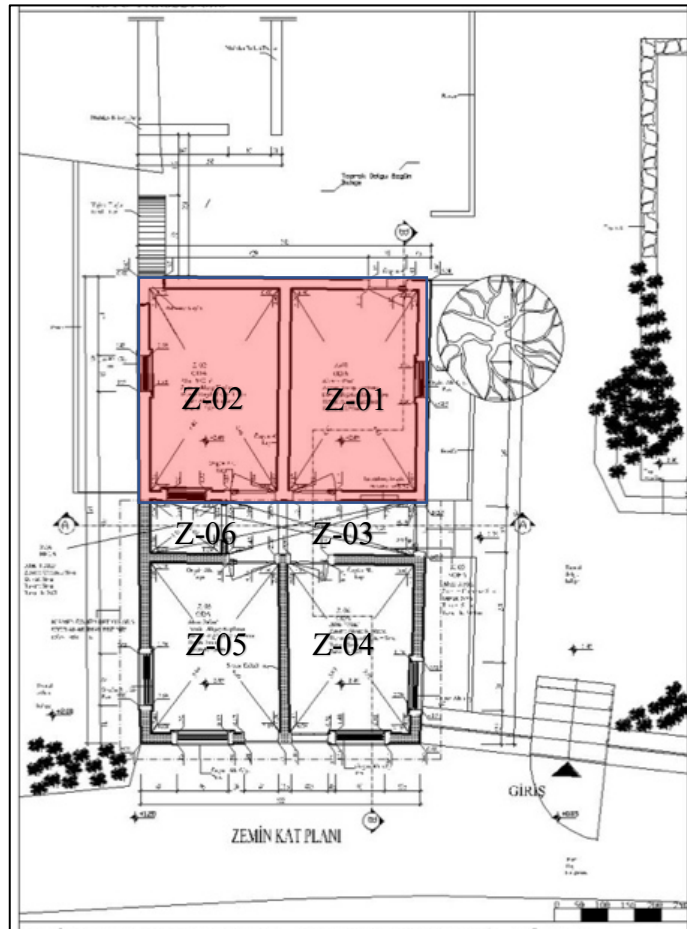
There were 4 rooms (Z-01, Z-02, Z-04, Z-05), an entrance hall (Z-03) and a toilet (Z-06) on the ground floor (Figure 6). Room Z-01 and room Z-02 were parts of the original boathouse structure, (Figure 7) while the other rooms had been added on later to the original boathouse (Figure 8). The building was entered by a door located on the northeast facade which opened unto the entrance hall (Z-03). Connection to the back garden was made from a door located in the northwest facade through room Z-01.

Figure 6. Ground Floor Plan (Tanrıverdi, 2011)

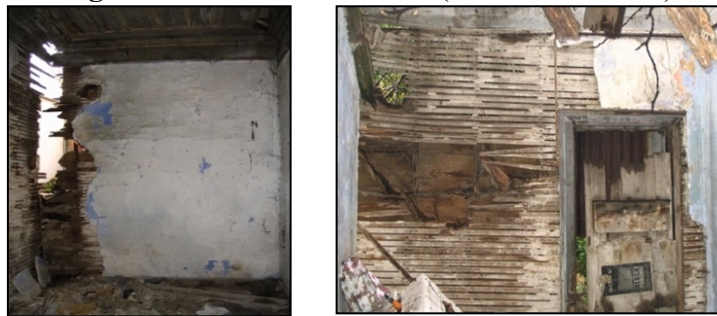
Figure 7. Photos of the original Z01 and Z02 rooms (Tanrıverdi, 2011)

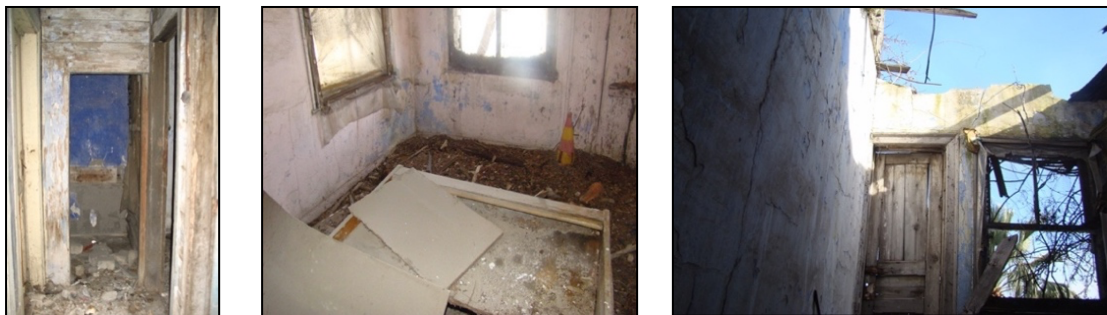
Figure 8. Photos of the added rooms Z-03, Z-04, Z-05 (Tanrıverdi, 2011)

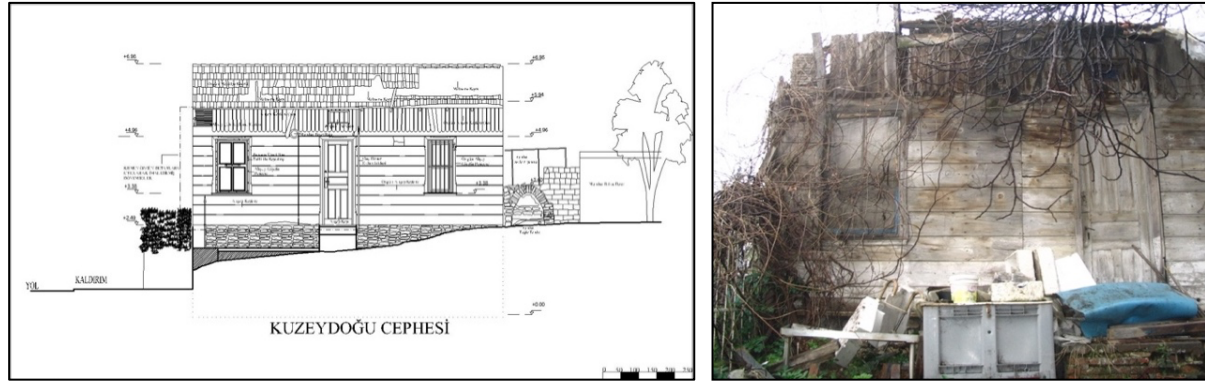
On the northeastern facade of the boathouse there were two guillotine windows in the middle of which was the main entrance door which could be reached by two steps. The original wooden and Marseille tile roof construction on this facade had largely disappeared. In the continuation of the northeastern facade, there was a brick tandoor oven, which was considered to have been added on later (Figure 11).

Figure 11. Drawing and Photo of Northeast Facade (Tanrıverdi, 2011)

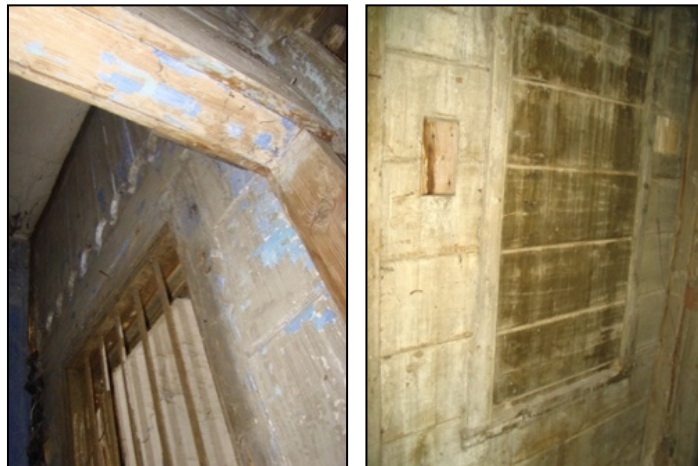
The original building materials of the boathouse were wood, stone, brick and iron. The basement floor walls were constructed with rubble stone, while its ceiling was made of a 'Jack arch' consisting of brick and iron beams (Figure 14). The floor of the basement was covered with natural earth material. The sub-basement level of the boathouse was constructed using rubble stone material of approximately 75 cm. in height, on which the ground floor spaces were constructed with wood. The inner surfaces of the ground floor walls were built using a wooden frame system covered with wooden lathes, which were then plastered and painted while the outer facades were completely covered with wood. However, in the first evaluation of the boathouse in 2011, the connecting wall between the entrance hall Z-03 and rooms Z-06, Z-01 and Z-02 was actually found to be an unplastered exterior wooden-covered facade showing traces of the first original building period. On the remains of this original wall were two guillotine windows, one of which had rusted iron bars (in the toilet section) while the other (opening unto space Z-01) was covered with wood (Figure 13).

Figure 13. Traces of the first original building period: iron-barred guillotine window and wooden covered guillotine window (Tanrıverdi, 2011)

According to the investigations carried out on the building it was discovered that rooms Z-01 and Z02 still carried both traces of interior lathed ceilings and wooden coverings (Figure 14) as well as traces of the front exterior facade covering of the first period (Figure 13). From this data it was determined that in the original building's first period, when the building was being used primarily as a boathouse, these rooms must have been used as spaces where the boatman lived, the boat passengers waited and fishing nets were stored. It was concluded that the rooms Z-03, Z-04, Z-05 and Z-06 must have been added on much later and were in fact originally a covered terrace as in other independent Ottoman boathouses. Also with respect to the data gathered from the elevations of the land and the ground level of the boathouse it was concluded that the sea used to enter the boathouse building at the basement floor (B-01). Thus it was understood that whenever the boatman used to bring a boat into the boathouse, anyone living in the mansion could reach the garden by means of the outer stairs built from the setwall. The basement and ground floor plans of the original boathouse were then drawn according to these conclusions (Figures 18).

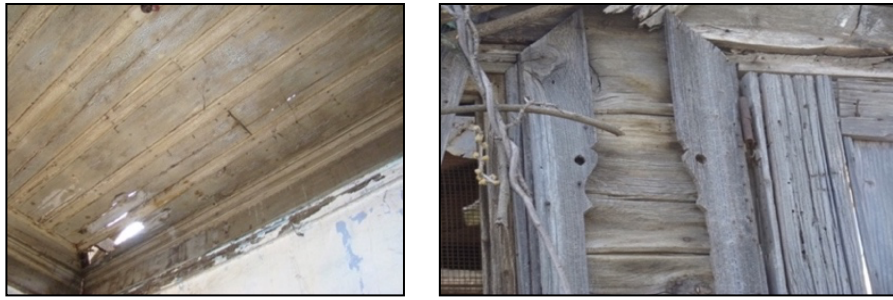
The ceiling of the surviving original Z-02 room in the building, was covered with wooden lathes. With the exception of the entrance hall (Z-03) and Z-06 (the WC area) which had floors made of compressed earth floors, all the other rooms had wooden floors. (Figure 14).

Figure 14. Wooden lathed ceiling of room Z-02 and the wooden decorations around the guillotine window (Tanriverdi, 2011)

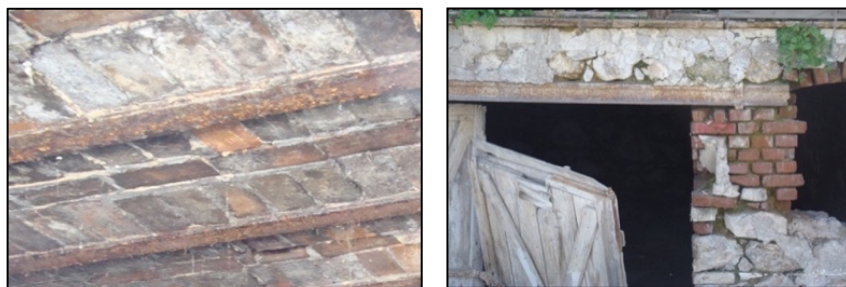
As a result of the road being constructed in front of the boathouse building, the basement floor which was now located below road level could not get proper ventilation thus causing deterioration in the building materials due to moisture. When the damage analysis of the basement floor of the boathouse structure was examined, loss of materials, cracks and salinization were found in the rubble stone walls. Rusting had taken place in the iron beams of the Jack arched ceiling and cracks as well as loss of broken off pieces were found in the bricks (Figure 15).

Figure 15. Deterioration of the metallic elements (Tanriverdi, 2011)

The basement floor was cleared of rubble and left in its original dimensions and form for public display. The empty wall-joints were filled-in with their appropriate original mortar material and the damaged volta bricks in the ceiling were replaced with new volta bricks. After mechanically and chemically cleaning the metal beams, anticorrosion paint was applied. Since this section was to be used as a temporary exhibition space and because it was now located below road level access was provided by designing new stairs and a ramp. The bricks and stones on the exterior of the basement floor facade were renewed according to their condition and the necessary joint fillings were made. The windows were repaired in accordance with the available data and information obtained from that of the window of the masonry ground floor of the painting studio room.

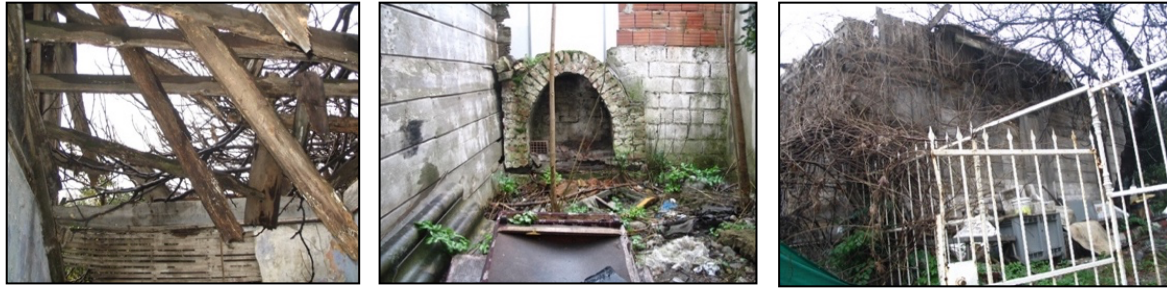
Wood rot, insect infestation, invasion of vegetation and the entrance of water through the damaged roof had caused loss in the wooden structure of the ground floor and the collapse of the roof. In addition to this, material loss, cracks and stains were also observed on the interior wall lathes and plaster. On all the facades of the building and the brick tandoor oven in the backyard biological deterioration, vegetation, and stains caused by the surfaces being washed by rain could be discerned (Figure 16).

Figure 16. Woden roof and biological deterioration (Tanriverdi, 2011)

The ground floor rooms Z01 and Z02 were preserved, whereas the other rooms (Z-03, Z-04, Z-05, Z-06) were removed and these spaces were turned into a terrace. First the damaged roof which had caused major damage to the whole building was repaired using the same wooden material. The wooden doors, windows, etc. of the exterior facade and interior spaces were repaired or replaced with new ones according to their condition. Rooms Z01 and Z02 were accepted as a part of the Osman Hamdi Bey Museum and a decision was made to use them for exhibition purposes. The terrace whose flooring, wooden railings, eave frontal boards were designed by looking at these same details in the mansion (a building structure of the same period), was to be used as an open exhibition space (Demirkol-Oğuz, 2014)² (Figure 22).

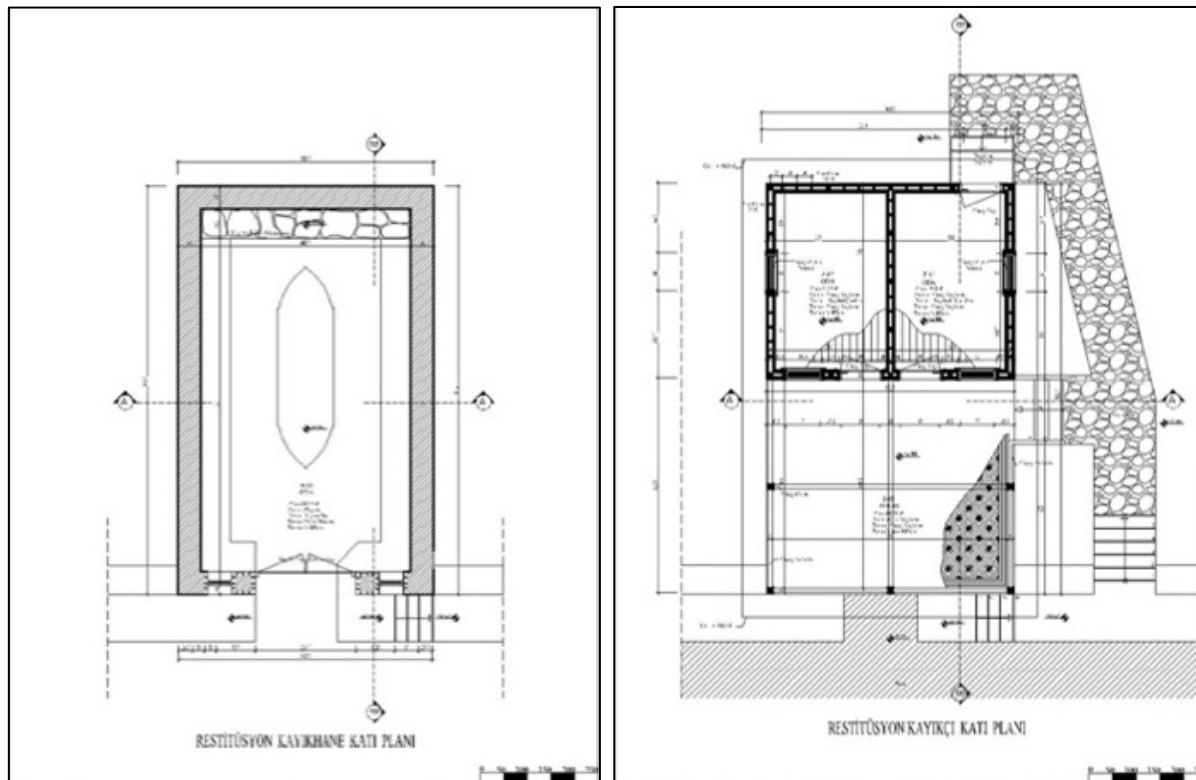
Figure 18. Restitution Plans of the Basement and Ground Floors (Tanrıverdi, 2011)

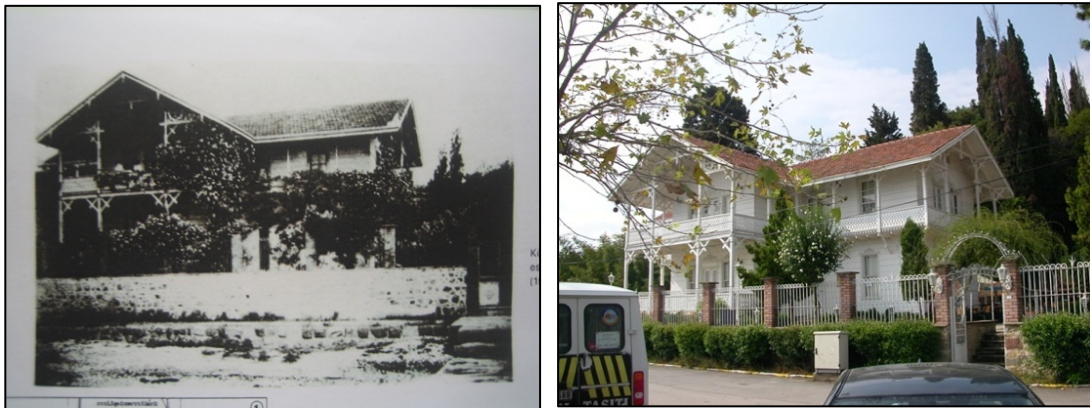
Figure 19. Osman Hamdi Bey's Mansion Building (Çetinor, 1993, 14) (Tanrıverdi, 2011)

It was discerned from the old archival photographs of the mansion building that this two-floored wooden structure had preserved the size and proportional ratios of its original facade (Figure 19). In accordance to this, the wooden facade, window, door, balustrade and ornamental details

and mosaic decorations of the boathouse's ground floor terrace were determined using the original wooden facade, balcony and floor data of that of the mansion. Old photographs and literature survey showed, that the painting studio located on the same plot had also preserved its authentic facade proportions and materials (Figure 20). Therefore the stone wall, brick arched windows and wooden door details of the basement floor facade of the boathouse were drawn according to these details of the original painting studio (Figures 21 (1)-(2)-(3)-(4)).

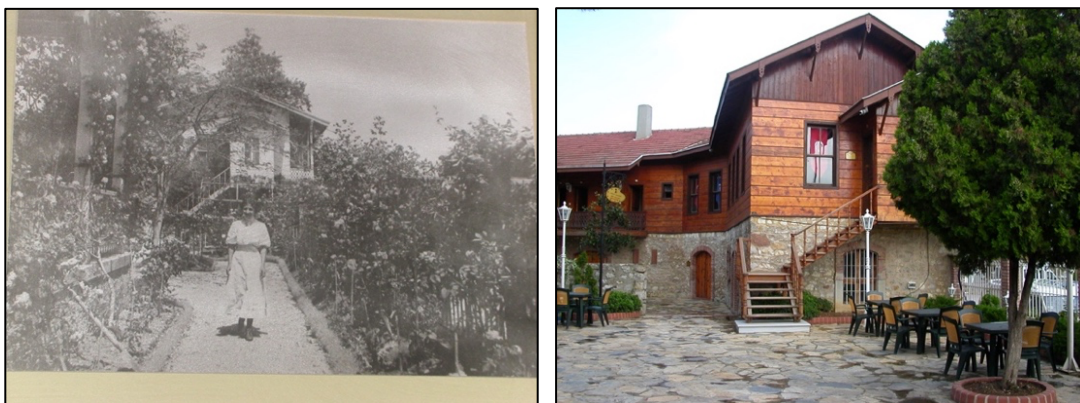
Figure 20. Osman Hamdi Bey's Painting Studio Building (Çetinor, 1986, 10) (Tanrıverdi, 2011)

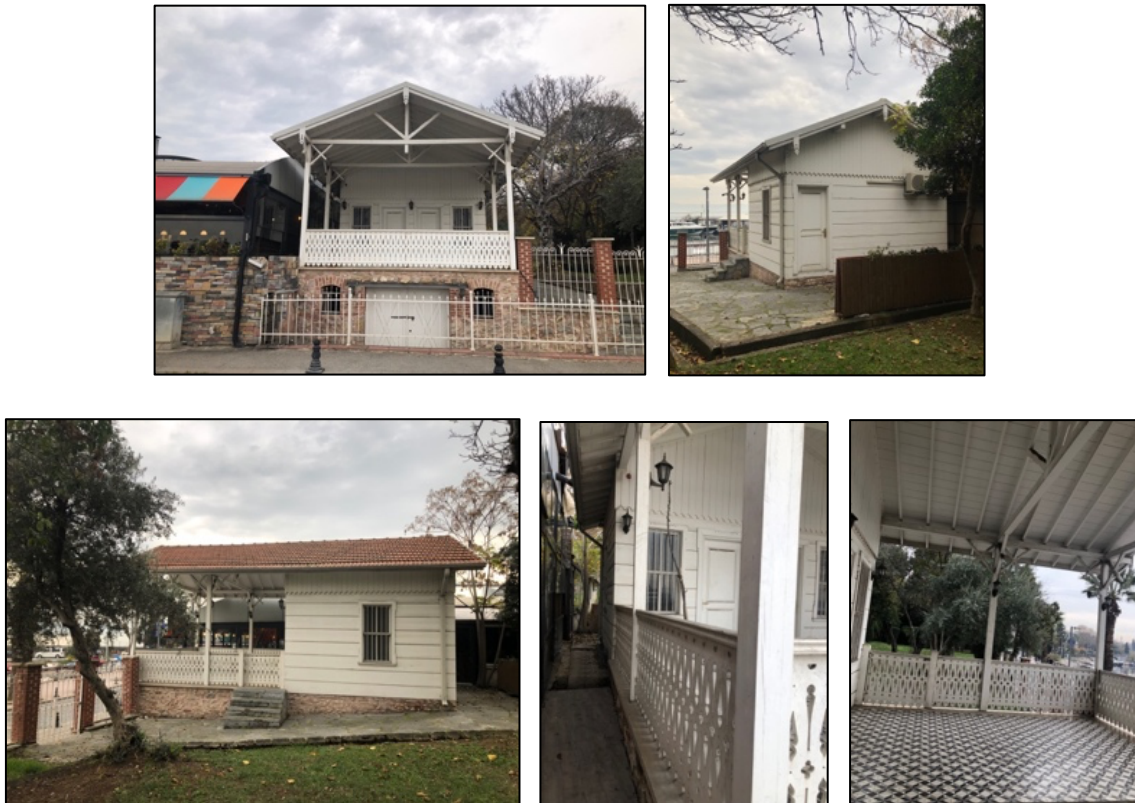
Figure 22. (1) Southeast-Northwest (2) Southwest-Northeast Facades after restoration (Tanriverdi, 2022)
